**DEBRIS/ICE/TPS ASSESSMENT and
INTEGRATED PHOTOGRAPHIC ANALYSIS
OF SHUTTLE MISSION STS-110**

Armando Oliu
Process Engineering/Mechanical System Division/ET-SRB Branch,
Kennedy Space Center, Florida

April 8, 2002

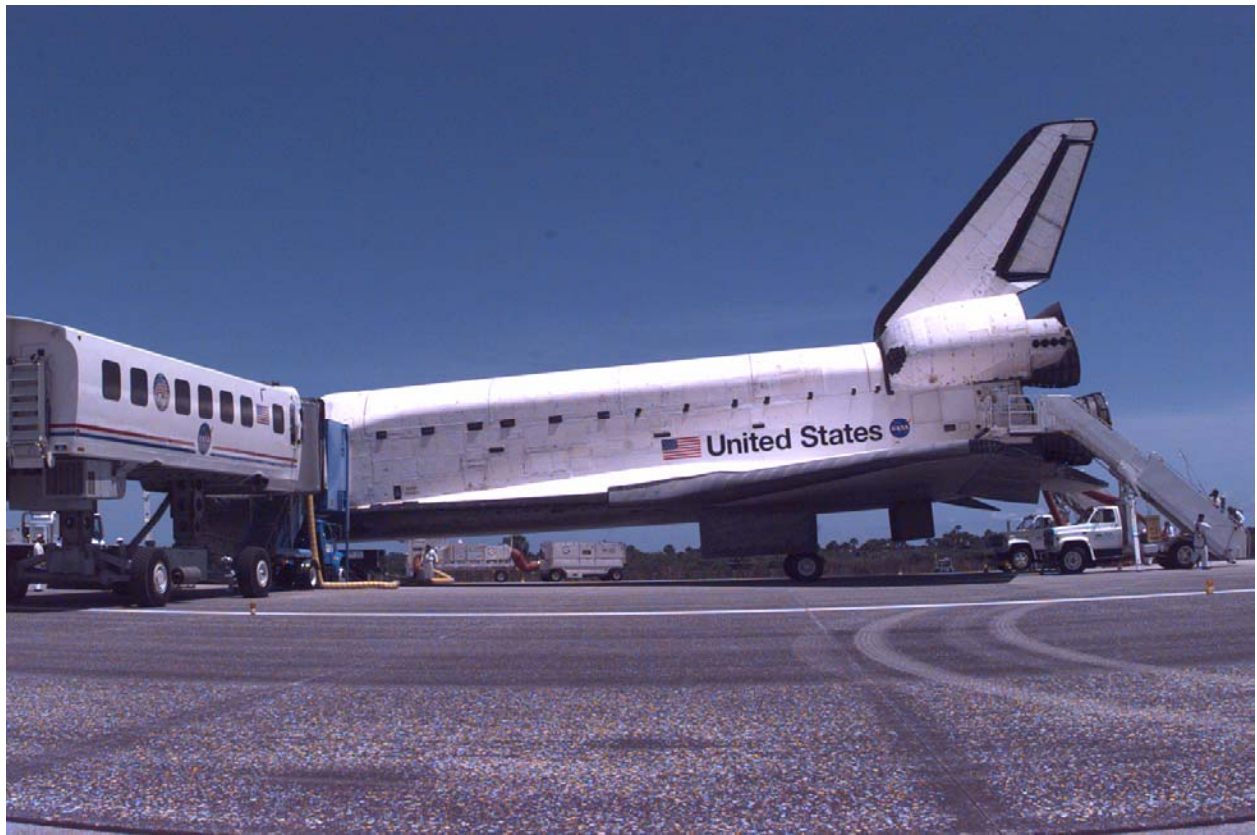
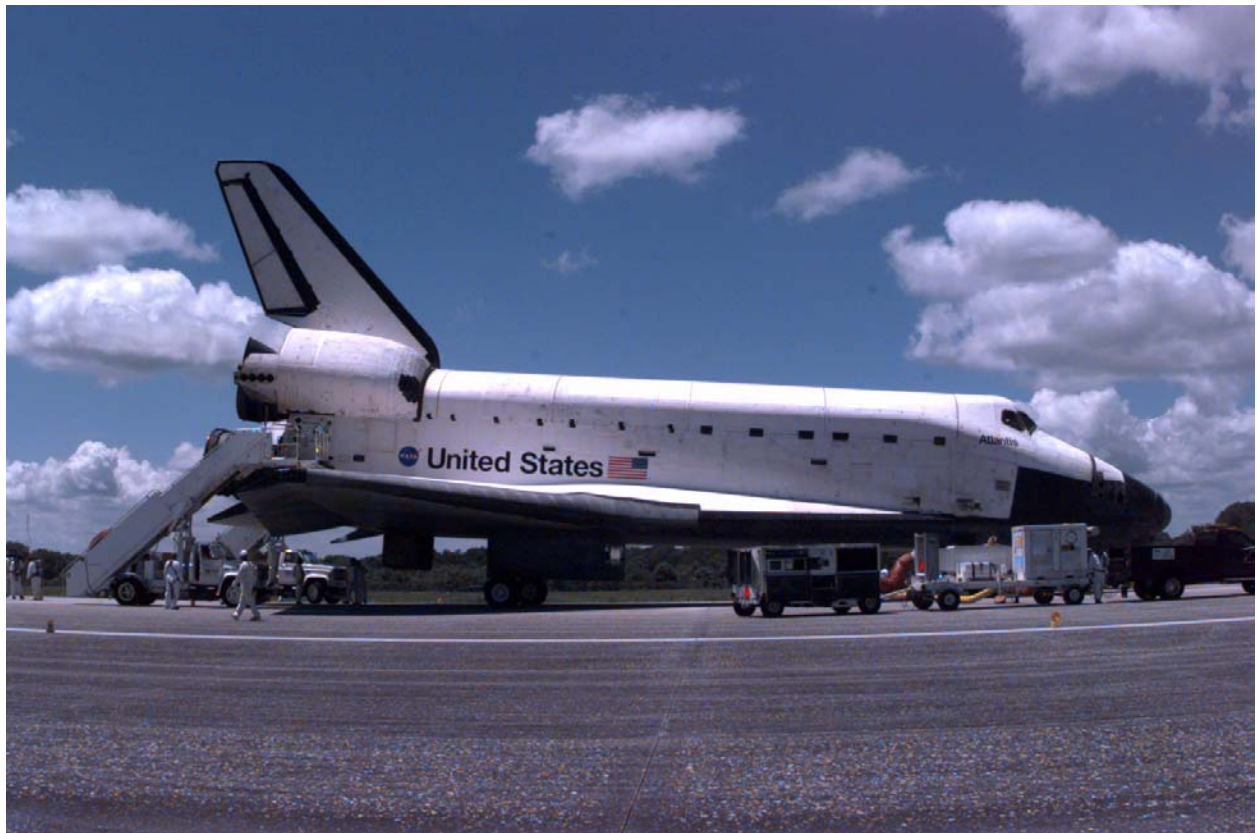
Photo 15: Overall View of Orbiter sides

The Orbiter lower surface sustained 70 total hits, of which 18 had a major dimension of 1-inch or larger, both numbers are well within family.

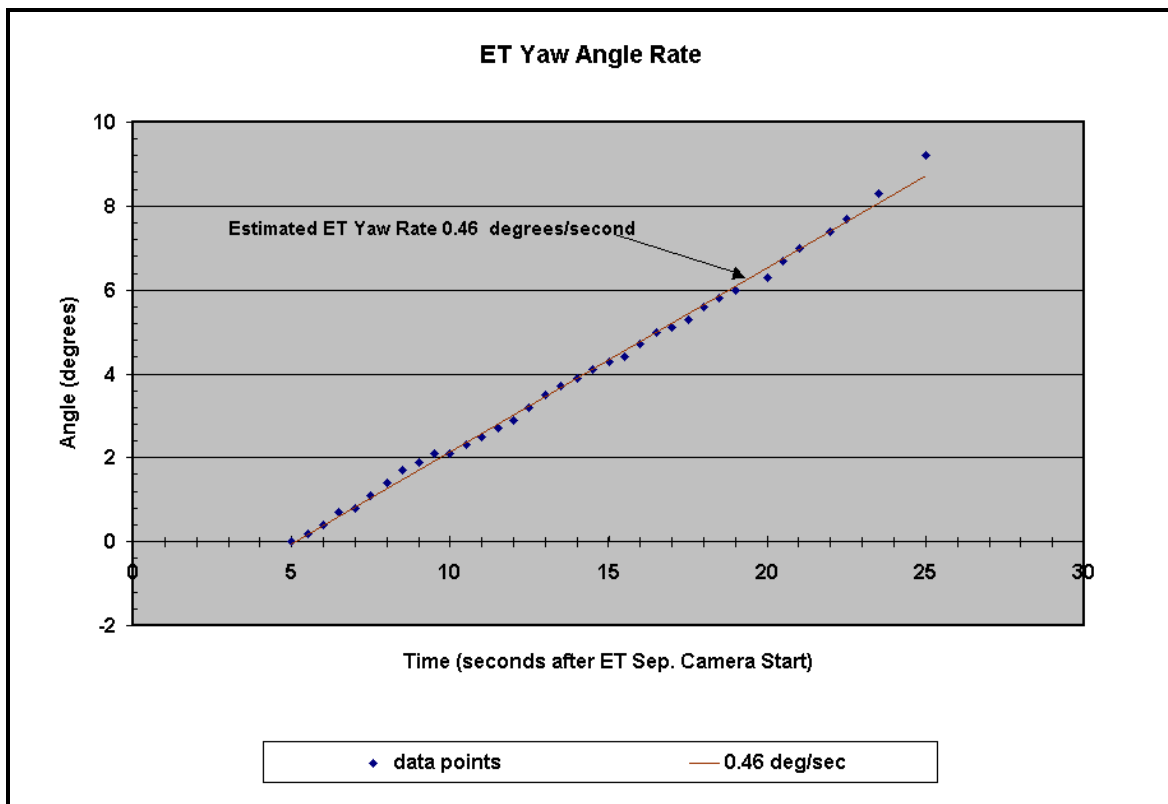
Figure 2.2 (B) External Tank Yaw Angle vs. Time from the 35mm Umbilical Well Camera Film

Boeing Integrated Ascent GN&C personnel reported that the apparent -Y movement of the ET on the umbilical well films was caused by residual angular velocity of the Orbiter due to the new OI-29 alpha-beta management (SCR 92353D) and is considered nominal behavior for STS-110 (and subsequent launches). Therefore, the apparent motion of the ET seen on the umbilical well films was due to the Orbiter's relative motion and was not an IFA condition.

The apparent yaw angle of the ET vs. time was measured to be 0.46 ± 0.04 degrees/sec from the 35mm umbilical well camera film. See Figure 2.2 (B). This was comparable to

Boeing's 0.3 to 0.6 deg / sec relative yaw rate quotes due to the OI-29 alpha-beta management.

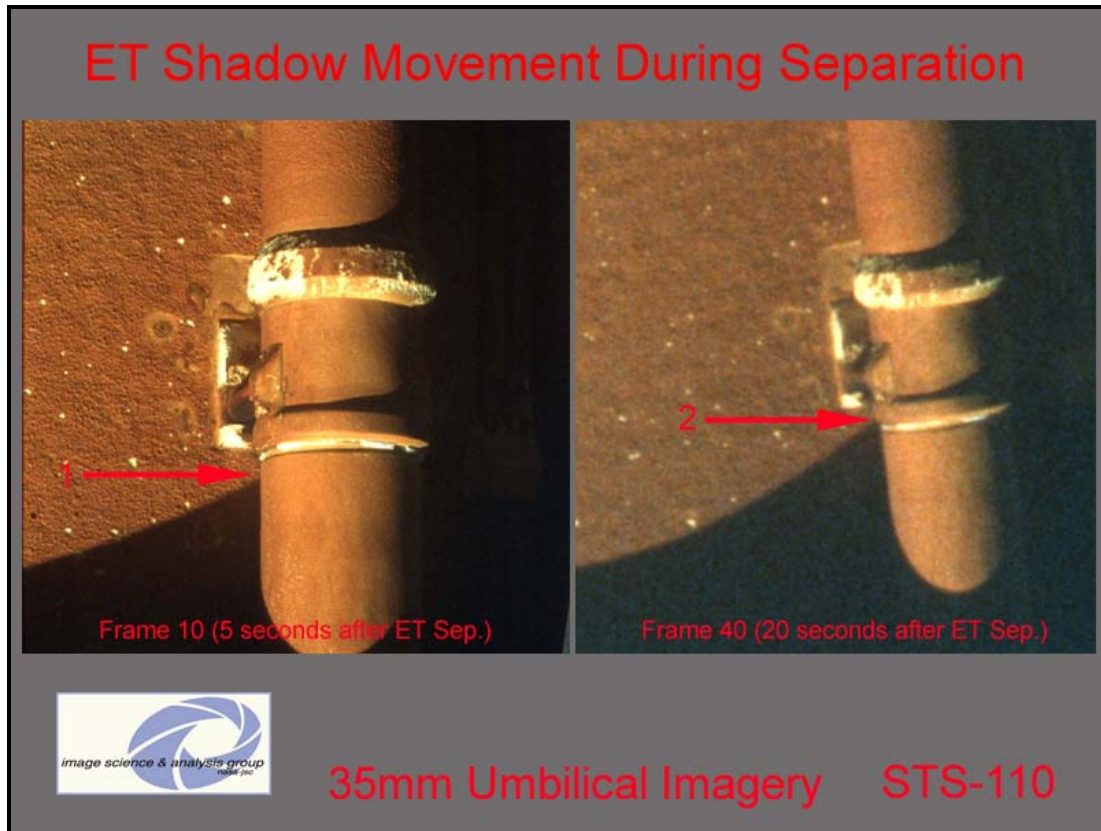
Figure 2.2 (C) Shadow Movement on the ET after ET Separation

The amount of movement of the shadow on the STS-110 ET was found to be comparable to the shadow movement seen on the STS-109 ET after separation. The change in movement of the STS-110 shadow on the ET during a fifteen second period can be seen in Figure 2.2 (C). This is consistent with the orbiter moving rather than the ET since the ET angle with respect to the sun is remaining relatively unchanged.

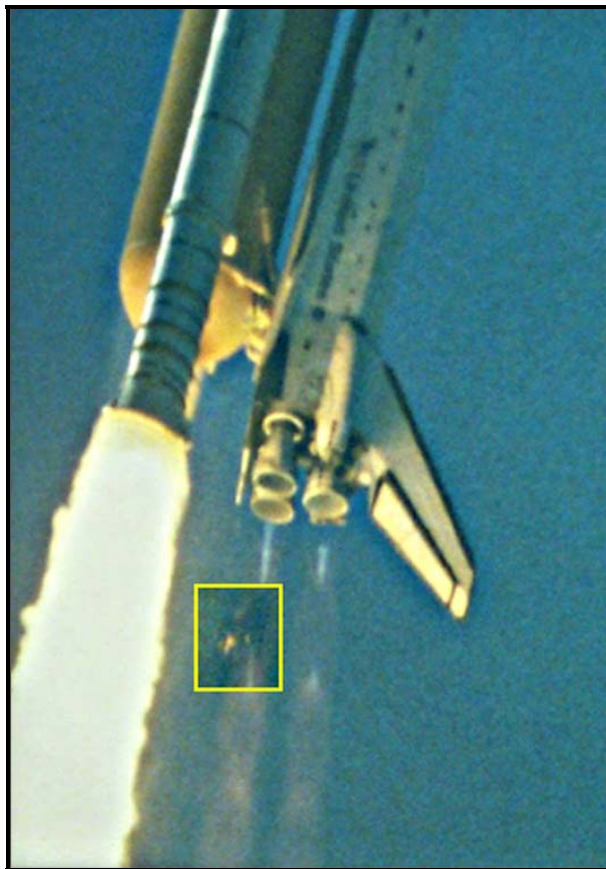
Figure 2.3.2 (A) RCS Paper Debris Spray Seen During Ascent (Camera E222)

Orange-colored debris (probably ET/Orbiter umbilical well purge barrier material) were seen falling aft along the body flap during ascent. On camera E207, a single piece of debris, possibly purge barrier material, was noted falling aft of the vehicle along the body flap, and fell aft into the SSME exhaust plume during ascent (20:44:37.409 UTC). On camera E223, multiple pieces of probable purge barrier material were seen falling aft along the body flap during ascent (20:44:47.993 UTC). On cameras E222 and E223, multiple pieces of debris (probable purge barrier material) were noted falling aft along the body flap during ascent (20:44:43.740 UTC, 20:44:47.996 UTC). ET/Orbiter purge material debris during ascent has been seen on previous mission imagery. (Cameras ET207, E207, E222, E223)

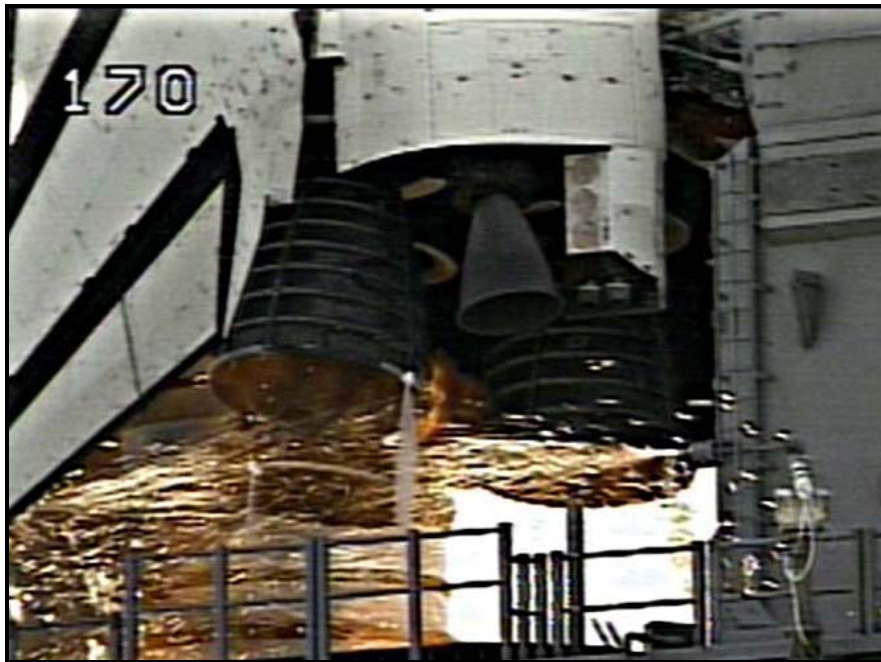
**Figure 2.3.3 Orange Vapor Seen Forward of SSME Rims Prior to Liftoff
(Camera OTV170)**

Orange vapor (possibly free burning hydrogen) was seen forward of the SSME rims, forward of the base of the vertical stabilizer, near the base heat shield, forward of the trailing edge of the OMS pods, and on the -Z side of the body flap during SSME ignition (20:44:13.790, 20:44:13.923 UTC). See Figure 2.3.3. Also, orange vapor was seen near the left and right SRB holddown posts (M-2, M-3, M-4, M-5, M-6, and M-7) during SSME ignition. Orange vapor forward of the SSME rims during SSME ignition has been seen on previous mission films and videos. However, the orange vapor appeared to be more extensive on the STS-110 films than was typically seen on previous mission films and videos. (Cameras OTV170, OTV163, E1, E2, E3, E4, E5, E8, E12, E13, E15, E16, E17, E18, E19, E20, E41, E52, E63, E76, E222)

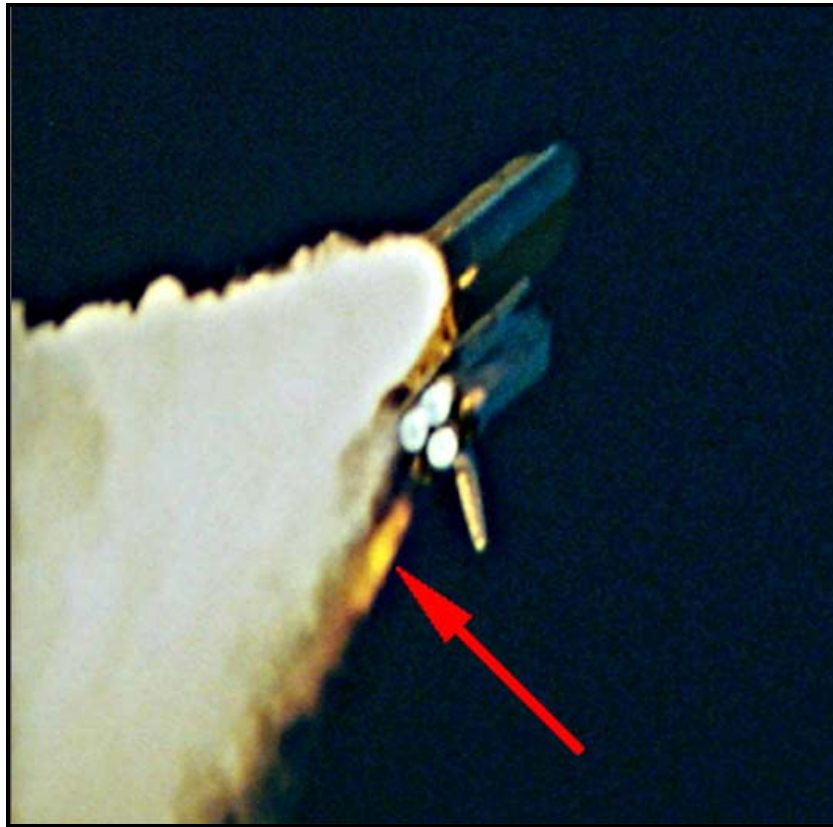
Figure 2.3.4 Flare Seen in SSME Exhaust Plume (Camera E222)

Light-colored flares (possibly debris induced) were seen in the SSME exhaust plumes during ascent on the intermediate and long range tracking camera films and videos. Many of these flares appeared to originate on the +Z side of the SSME exhaust plume near the trailing edge of the body flap. This could indicate that the flares were possibly induced by purge barrier material or pieces of tile material. See Figure 2.3.4. (Often on previous mission imagery, debris has been seen contacting the SSME exhaust plume resulting in visible flares. Usually this debris was RCS paper. On STS-26 and STS-101, debris that resulted in very large orange-colored flares was determined to have been tile material.) Examples of flares seen on STS-110 can be seen in Table 2.3.4. Flares in the SSME exhaust plumes have been seen on previous missions films and videos.

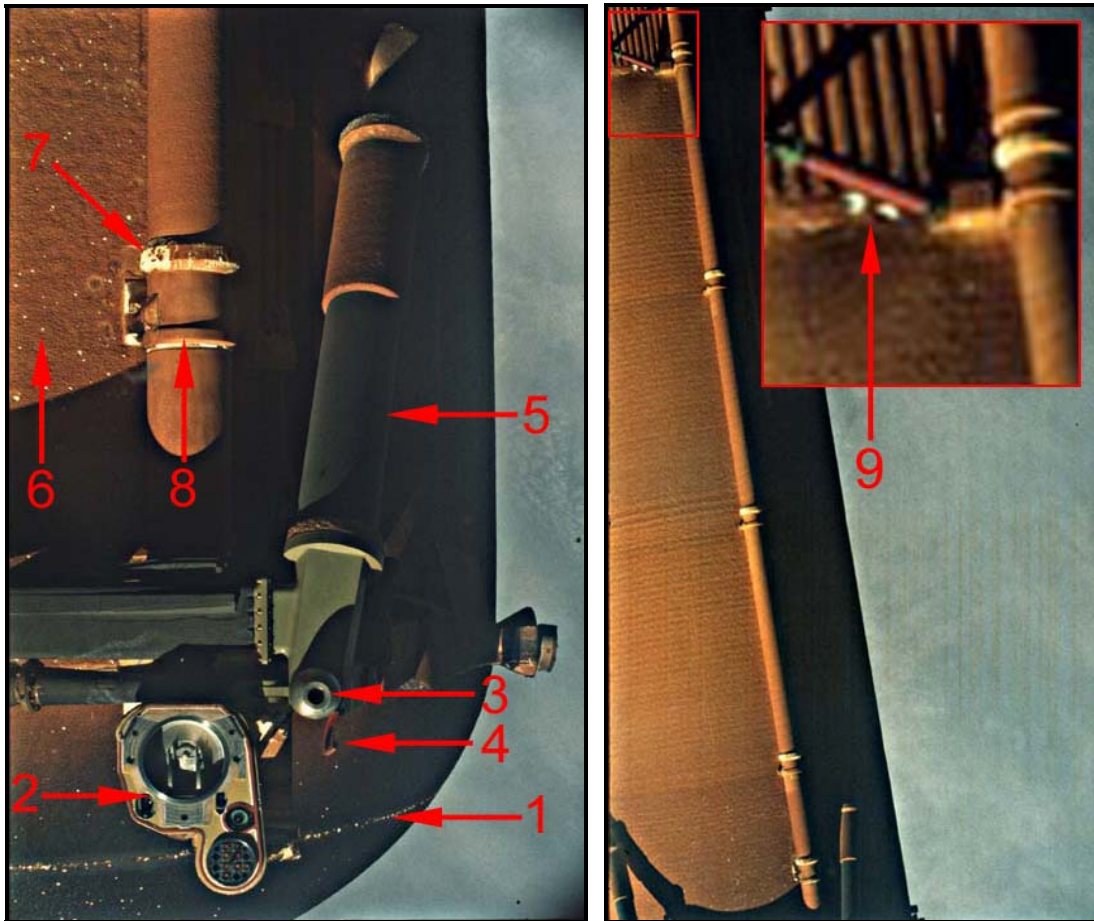
Figure 2.4.1 35mm Images of the External Tank during Separation

A long band of small, white-colored divots is visible on the ET aft dome TPS at the same level as the base of the LO2 umbilical. See Figure 2.4.1, annotation 1. Randomly located “pop-corn” divots have been typically seen on the ET aft dome on previous mission films. However, a long band of divots is not typically seen. Engineers at Michoud reported that this band of divots occurred at the interface of a spray gun stop and restart that took place during the application of the foam to the ET aft dome.

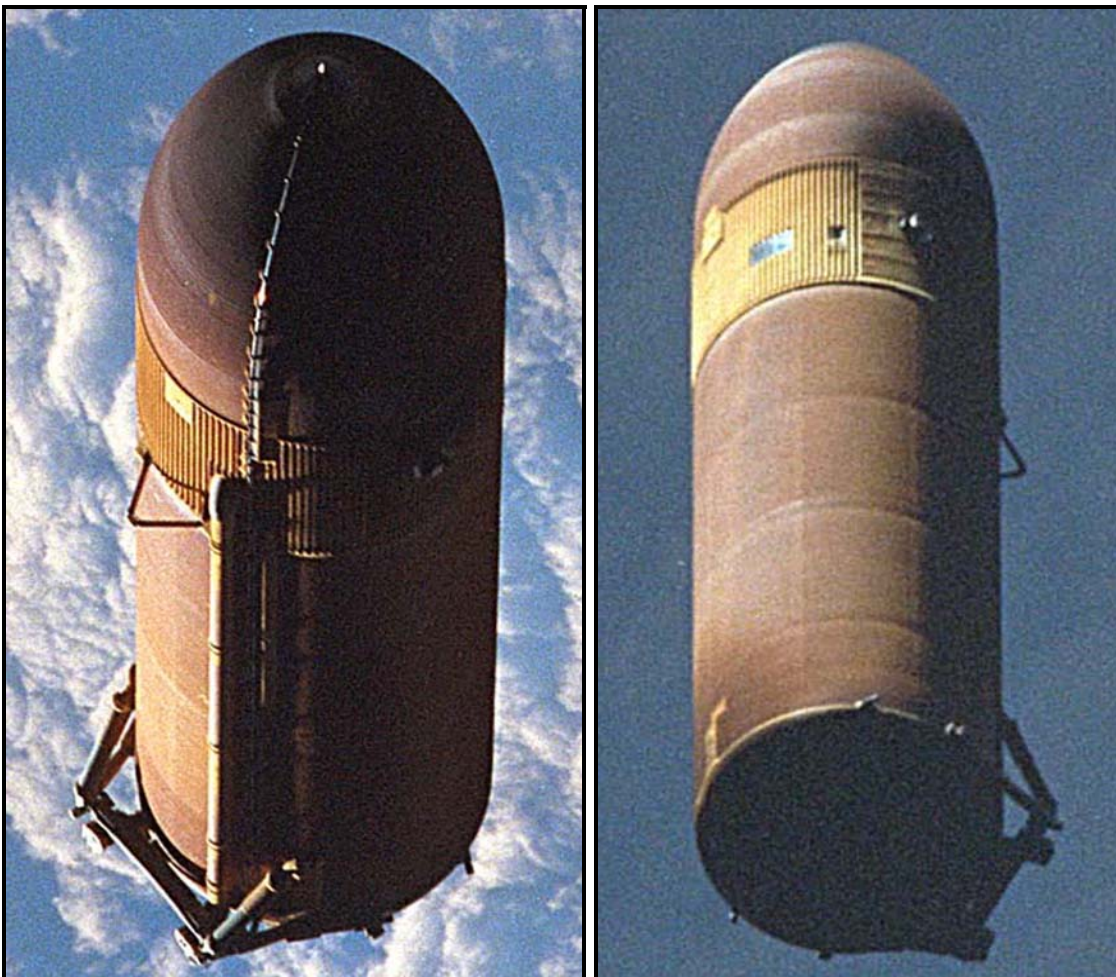
Figure 2.4.3 Handheld Images of the External Tank (Frames 1 and 11)

No anomalous or unusual observations were noted on the handheld film views. The analysis of the views was hindered because of the extensive shadows caused by the position of the ET relative to the late afternoon Sun. Eventually all sides of the ET, the ET aft dome, and ET nose were acquired as the ET rolled and pitched around its center of mass before the ET disappeared across the sunset terminator. The overall ET TPS

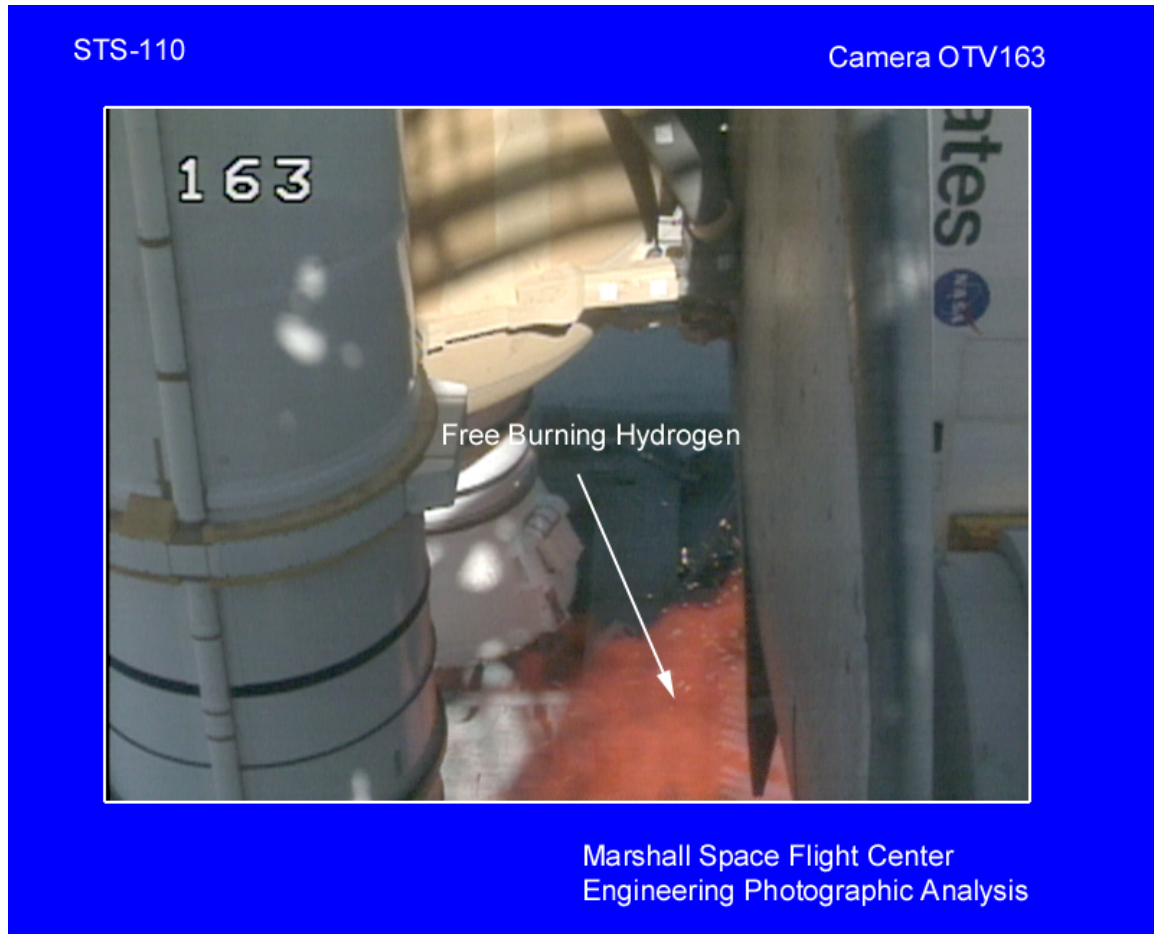
Figure 1. OTV163: Free Burning Hydrogen

Free burning Hydrogen was observed on the -Z side of the body flap at SSME startup.

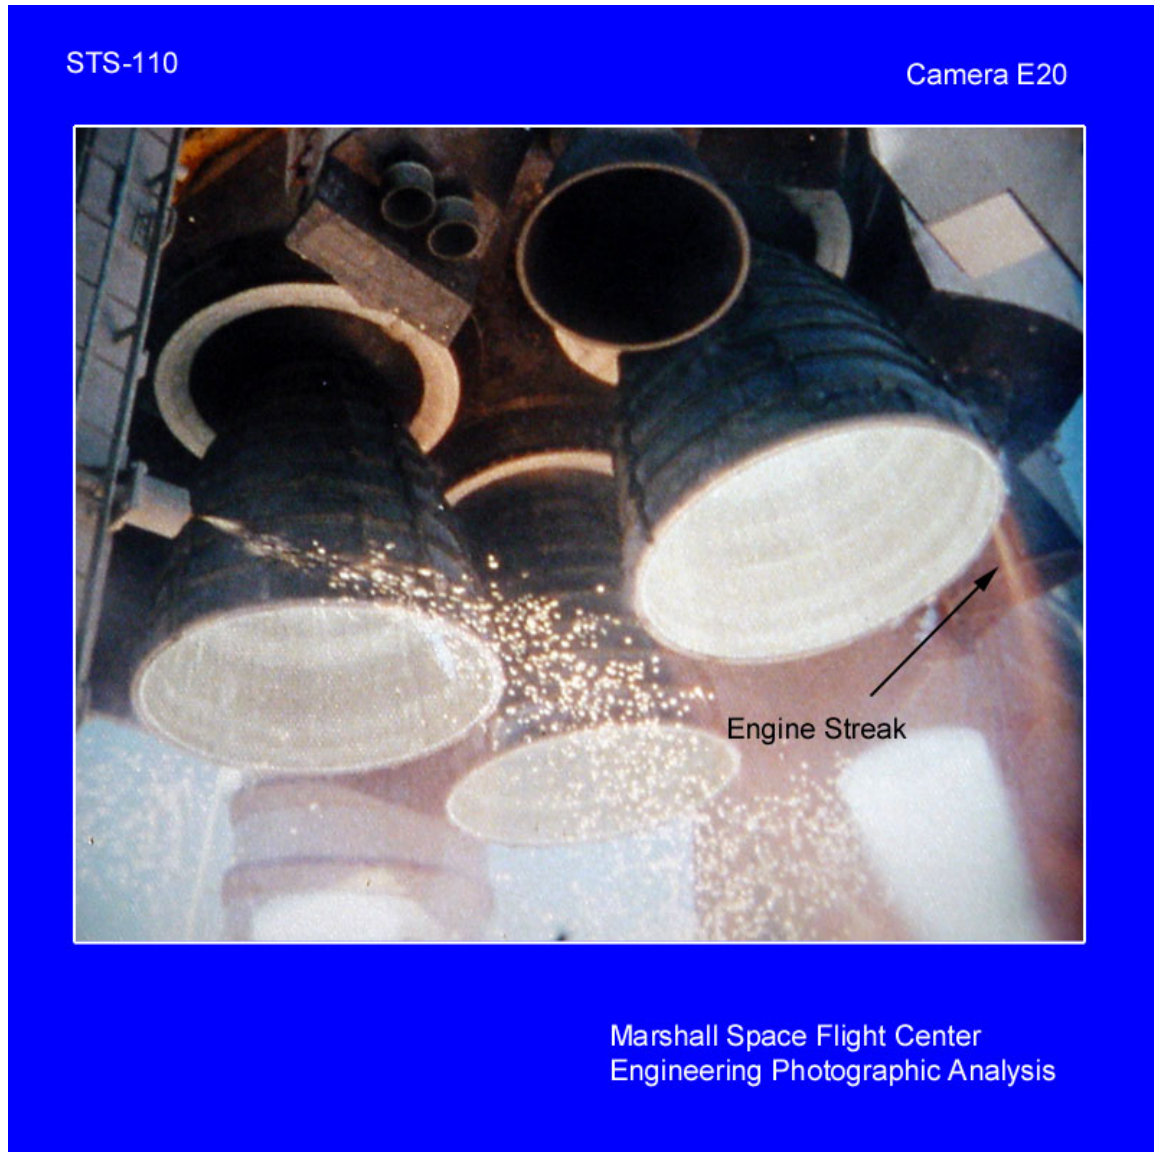
Figure 2. E20: Engine Streak in SSME Plumes

An engine-produced streak was noted in the SSME #1 plume prior to lift-off. This streak was imaged at 20:44:17.013 UTC. These faint streaks are common and are typically observed in SSME plumes just after SSME mainstage has been attained and prior to liftoff.

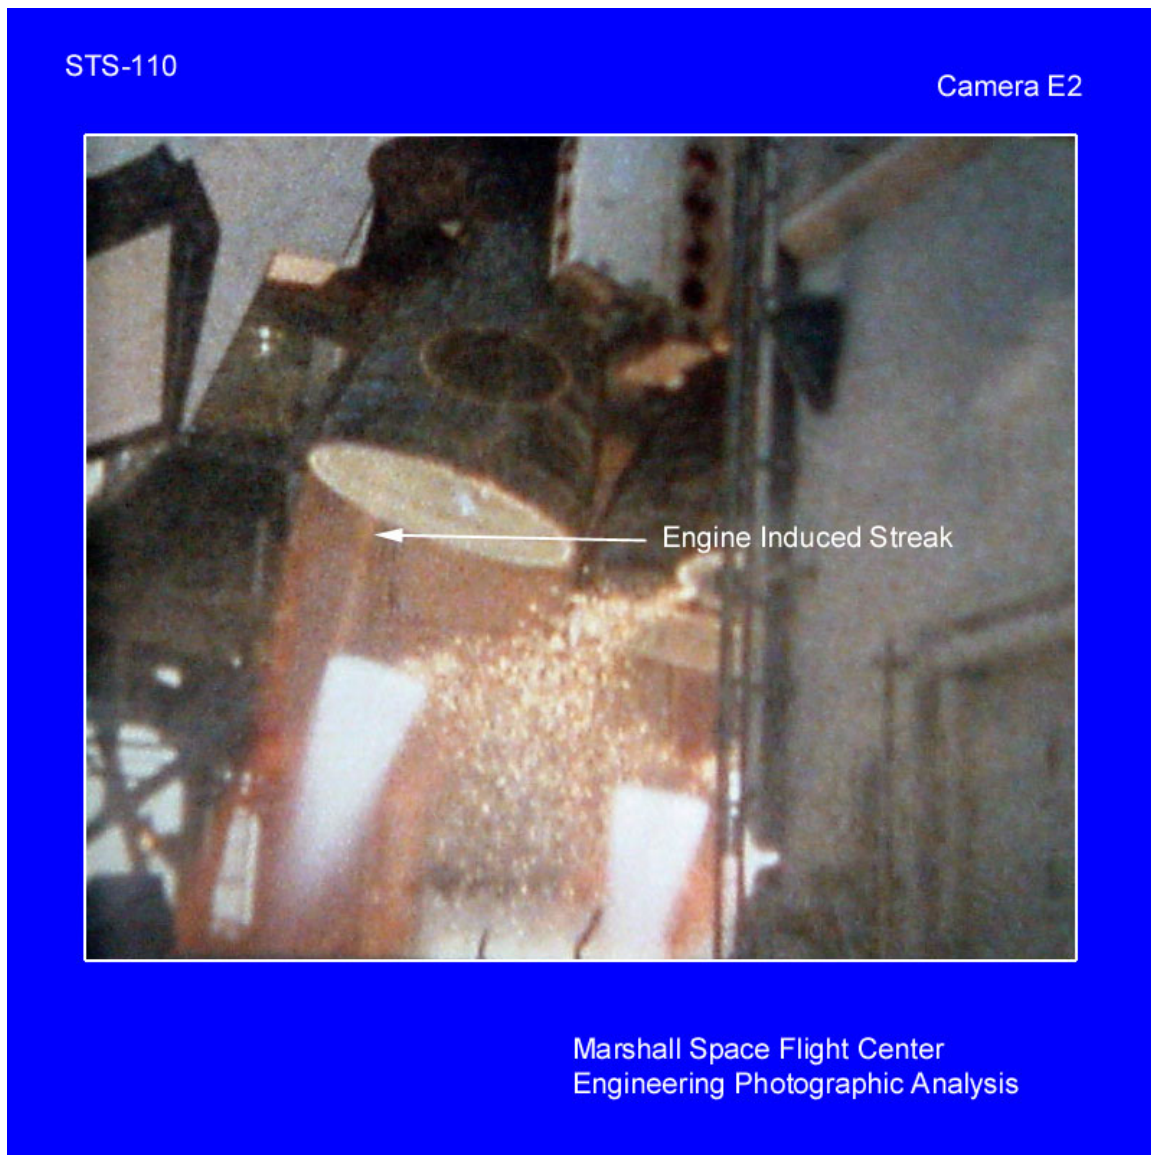
Figure 3. E2: Engine Streak in SSME Plumes

An engine-produced streak observed in the SSME plumes prior to liftoff. This streak was imaged at 20:44:17.085 UTC.

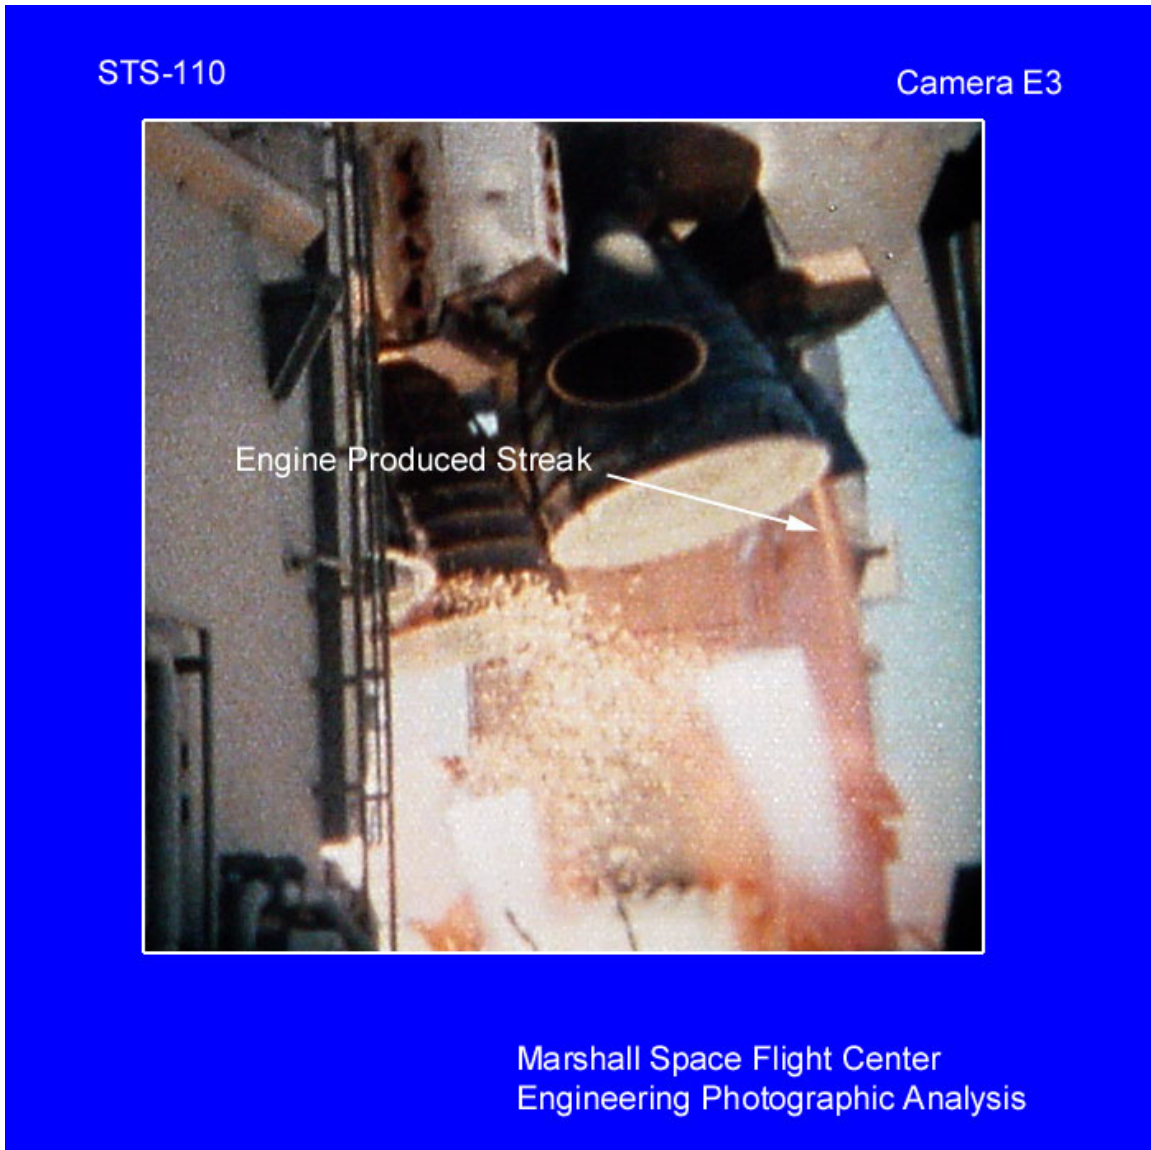
Figure 4. E3: Engine Streak in SSME Plumes

An engine-produced streak in the SSME plumes was observed prior to liftoff. This streak was imaged at 20:44:16.672 UTC.

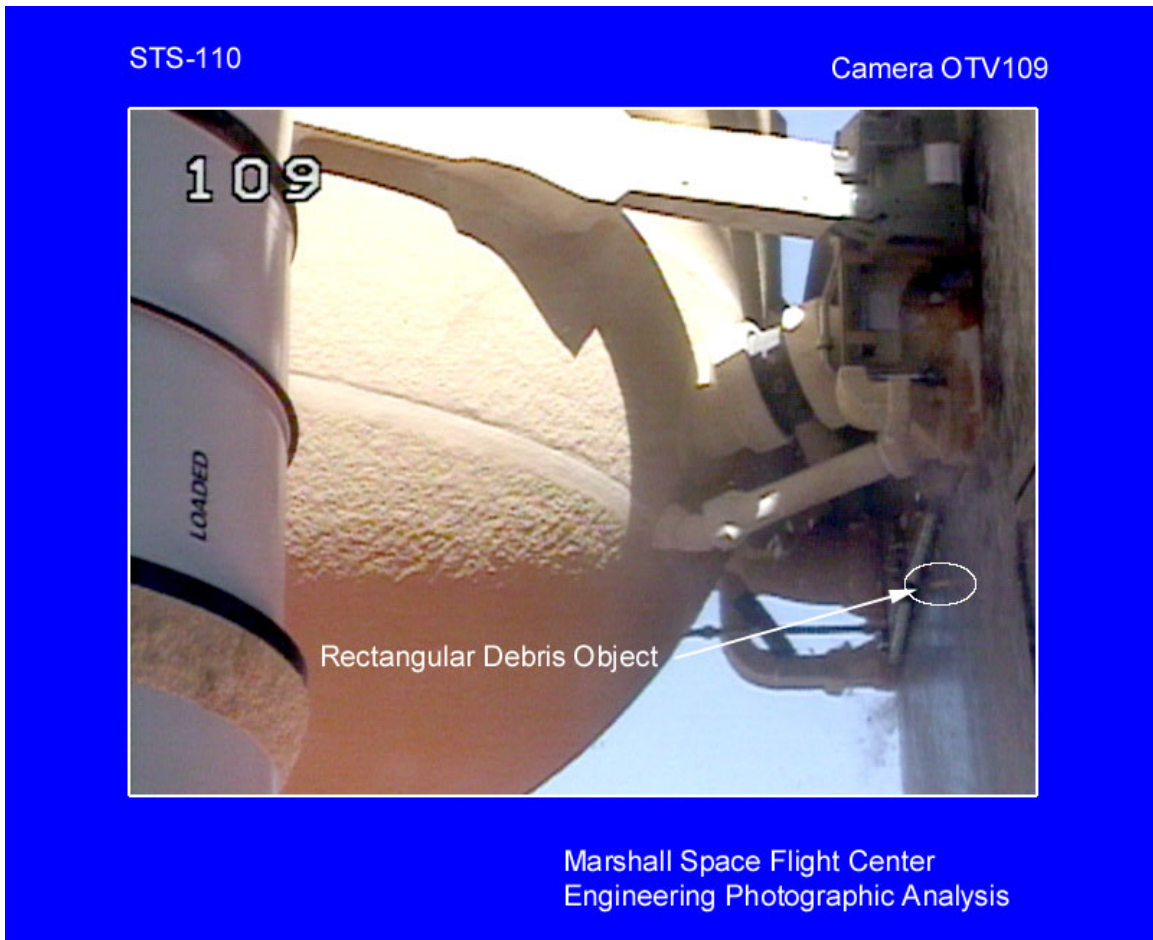
Figure 5. OTV109: Rectangular Debris Object

A yellowish rectangular shaped debris item was observed.

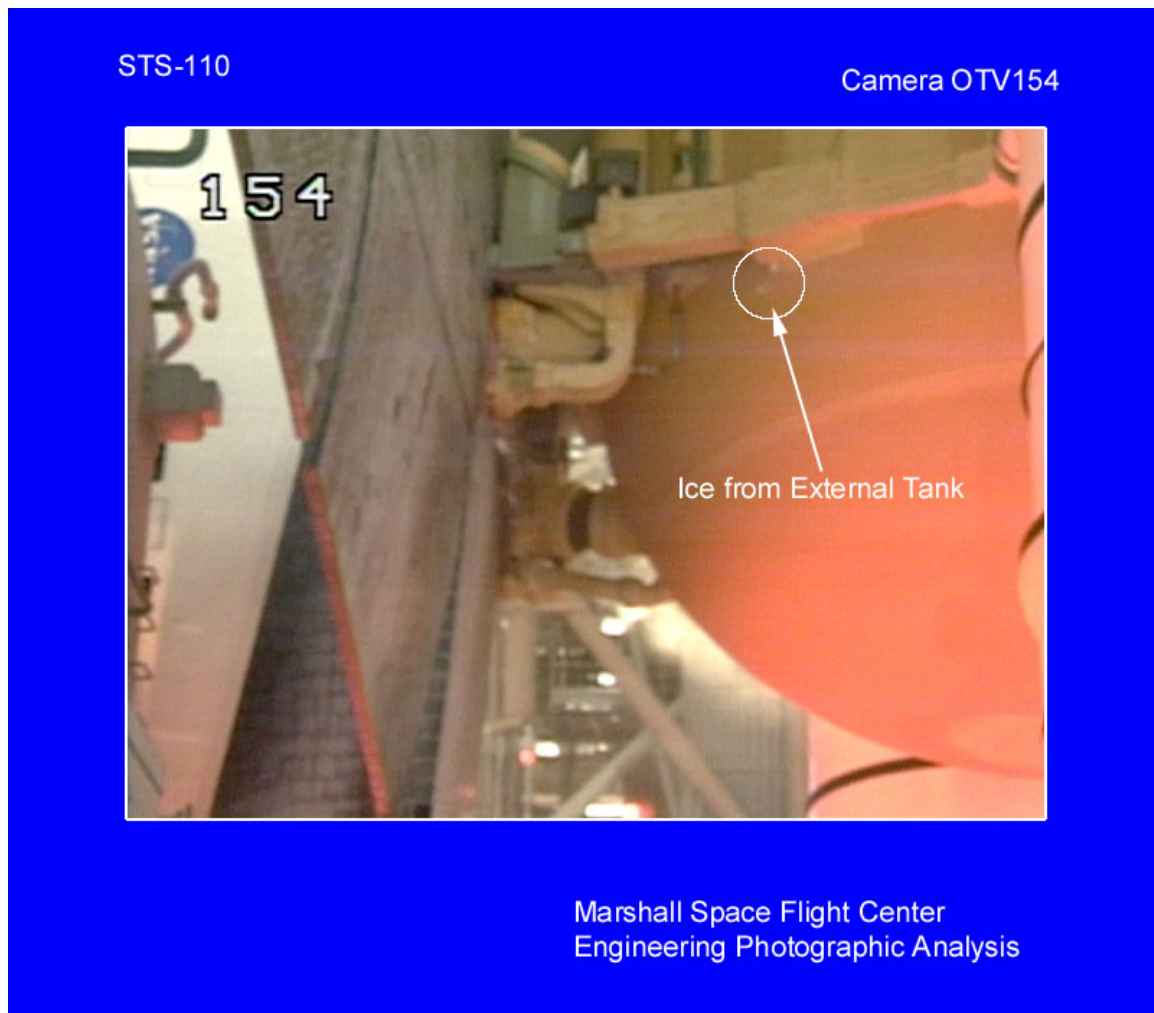
Figure 6. OTV154: Ice Debris from External Tank

Ice/frost debris was noted falling from the +Y side of the External Tank at the vertical strut ET attach point.

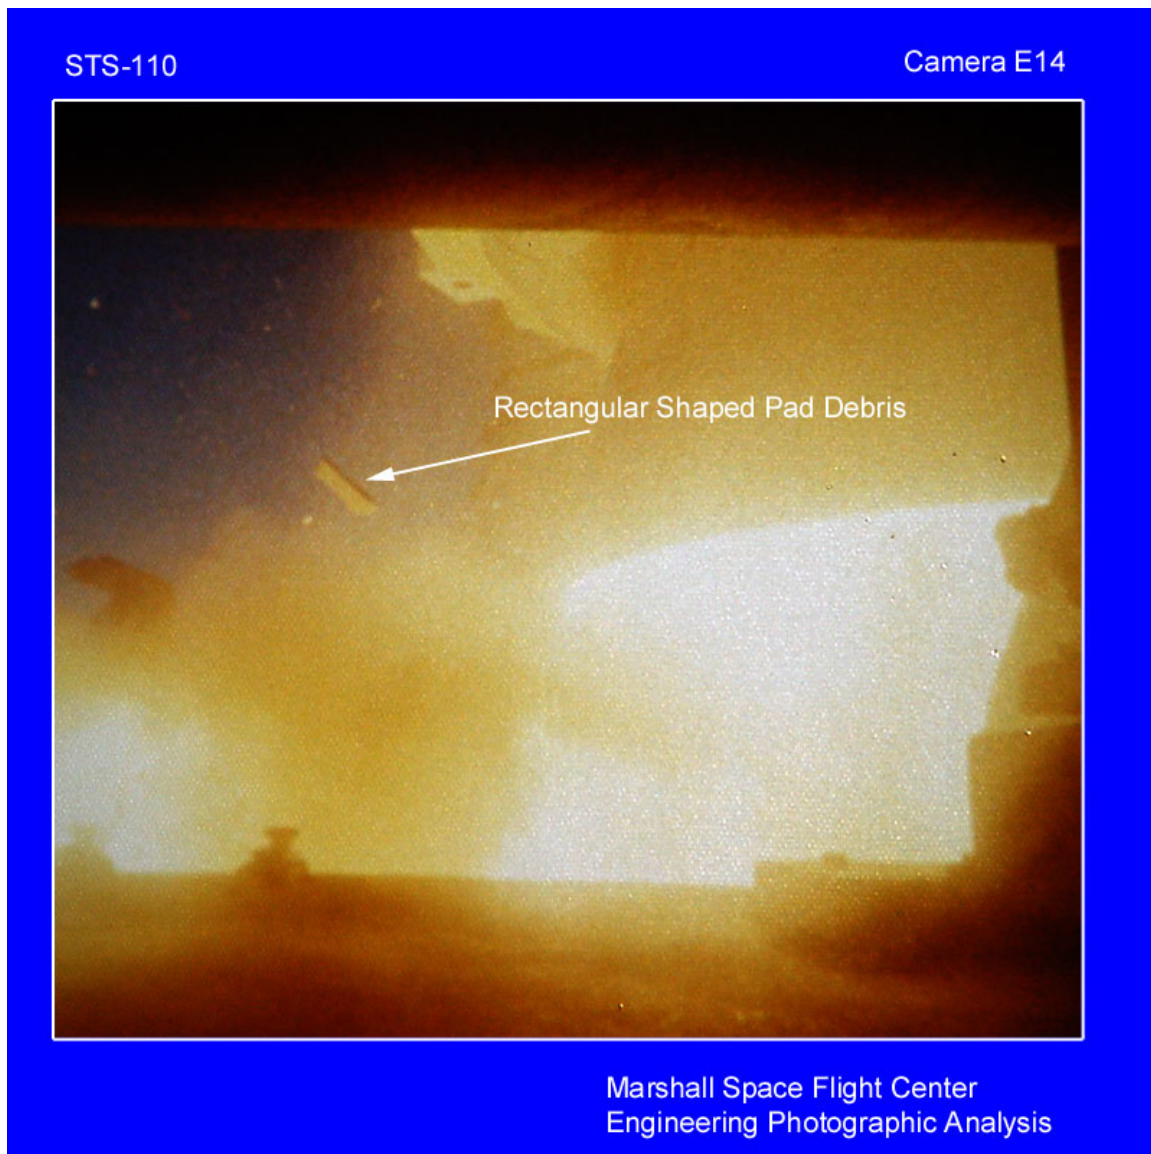
Figure 7. E14: Rectangular Debris Ejected from SRB Blast Hole

A large rectangular shaped debris item was ejected from the SRB blast hole.

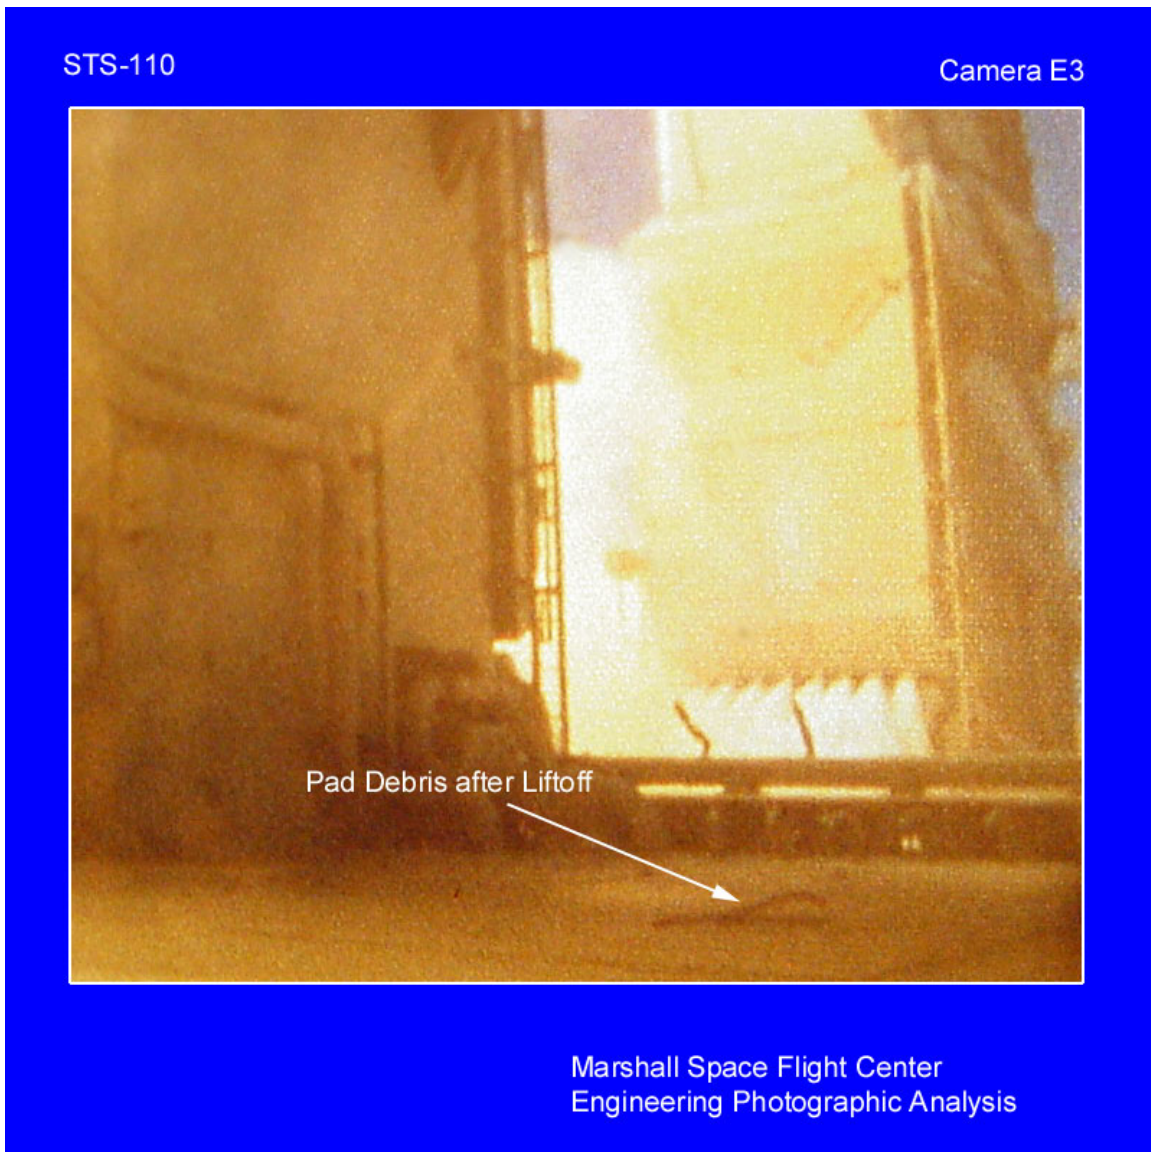
Figure 8. E3: Rope-like Debris on MLP Deck

A rope-like piece of debris material was observed moving across the MLP deck. This debris moved in a direction away from the launch vehicle.

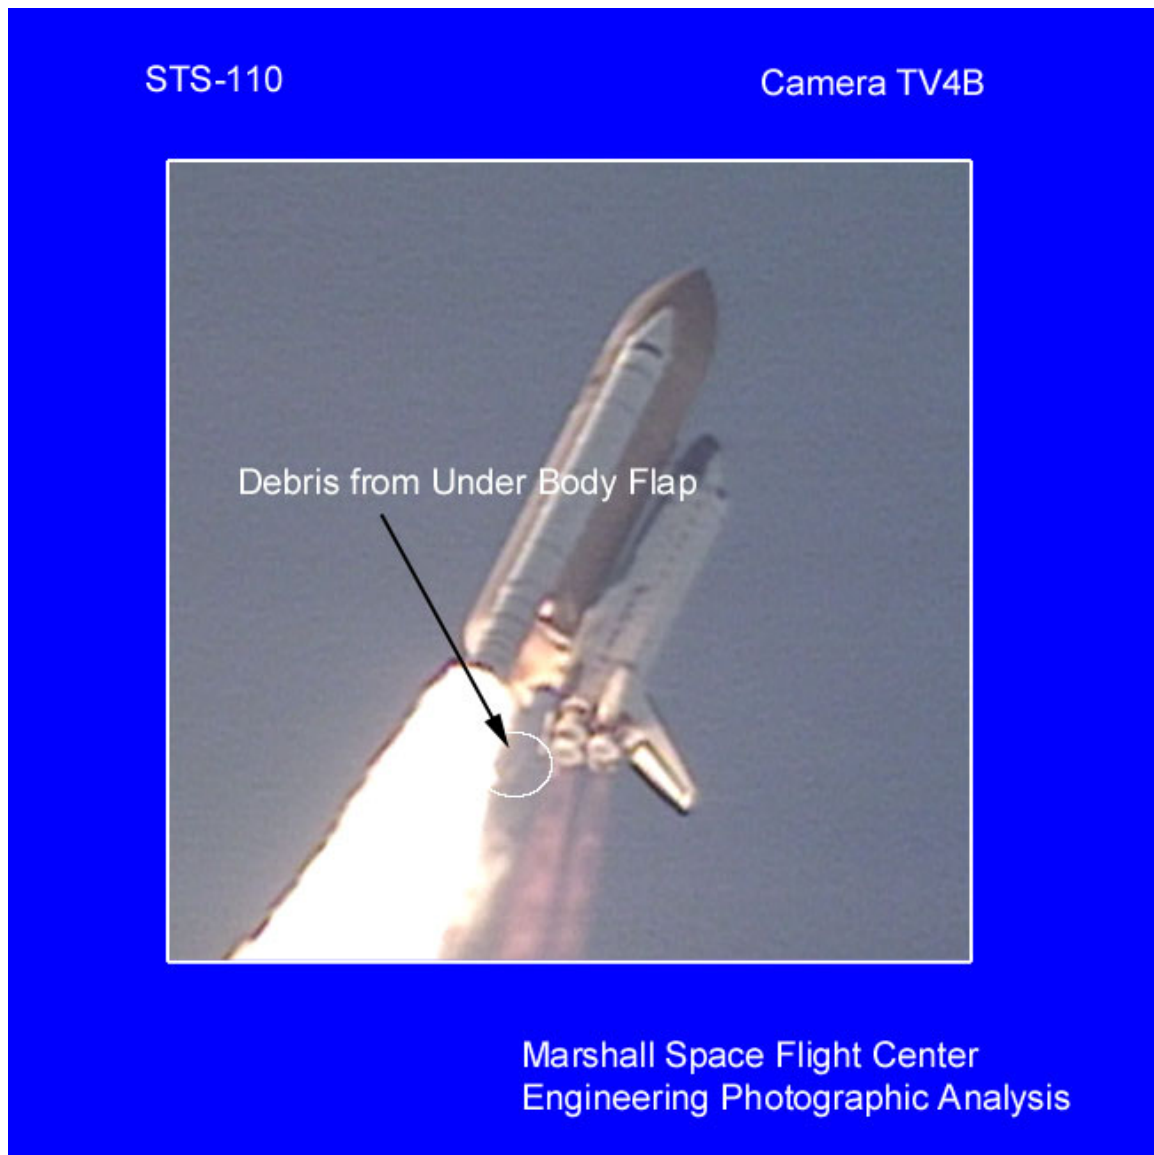
Figure 11. TV4B: Debris Under Body Flap

Debris material was observed emanating from under the body flap during ascent.

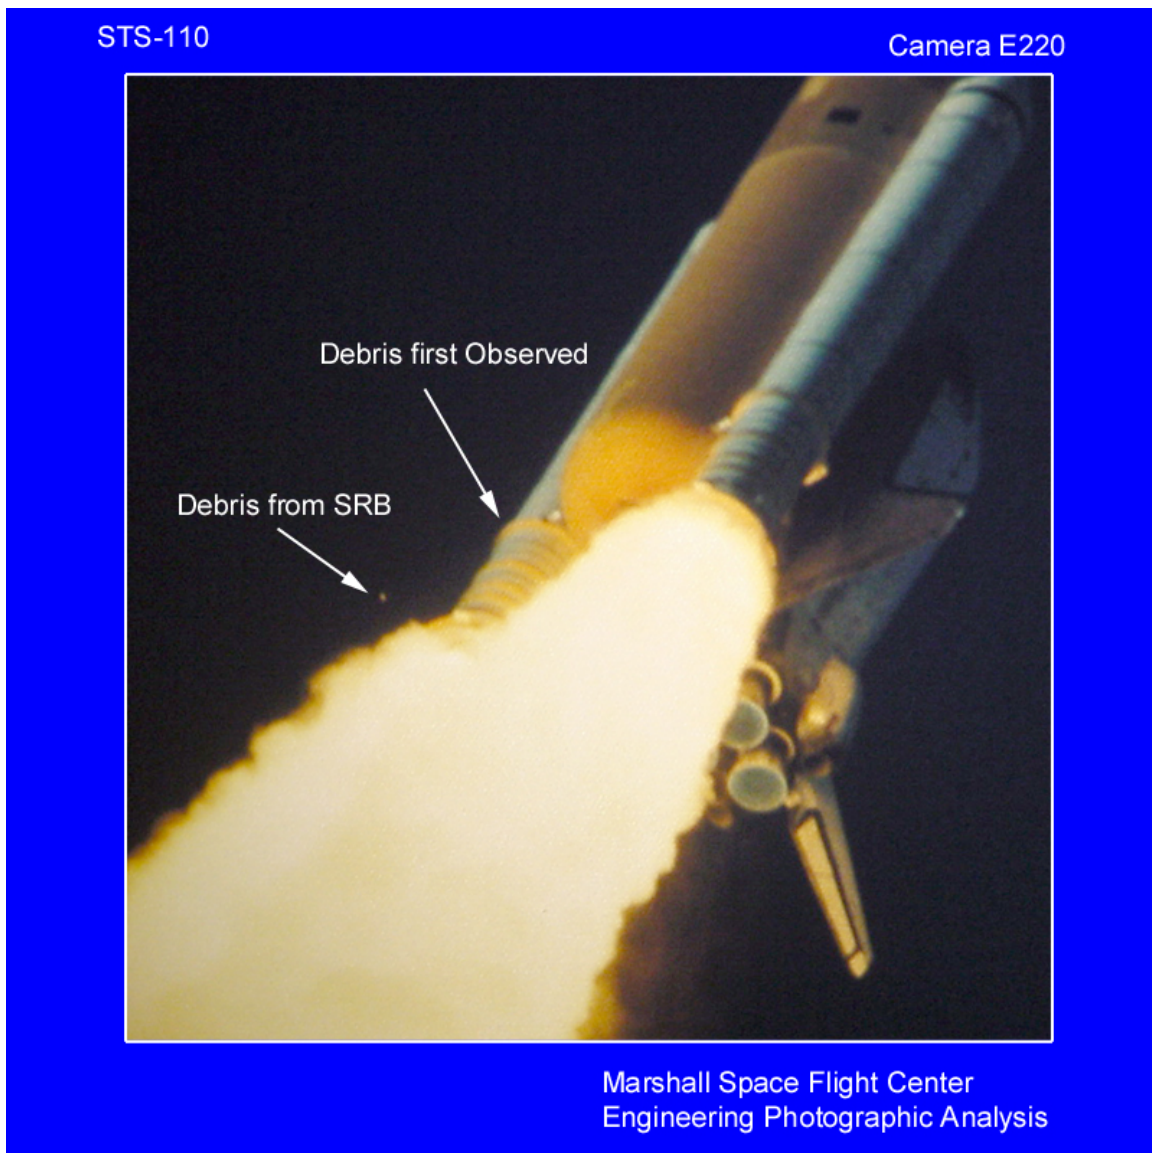
Figure 17. E220: Debris falling along side of SRB

Debris observed falling along side of SRB.
